Alaska District

BARROW STORM DAMAGE REDUCTION PROJECT

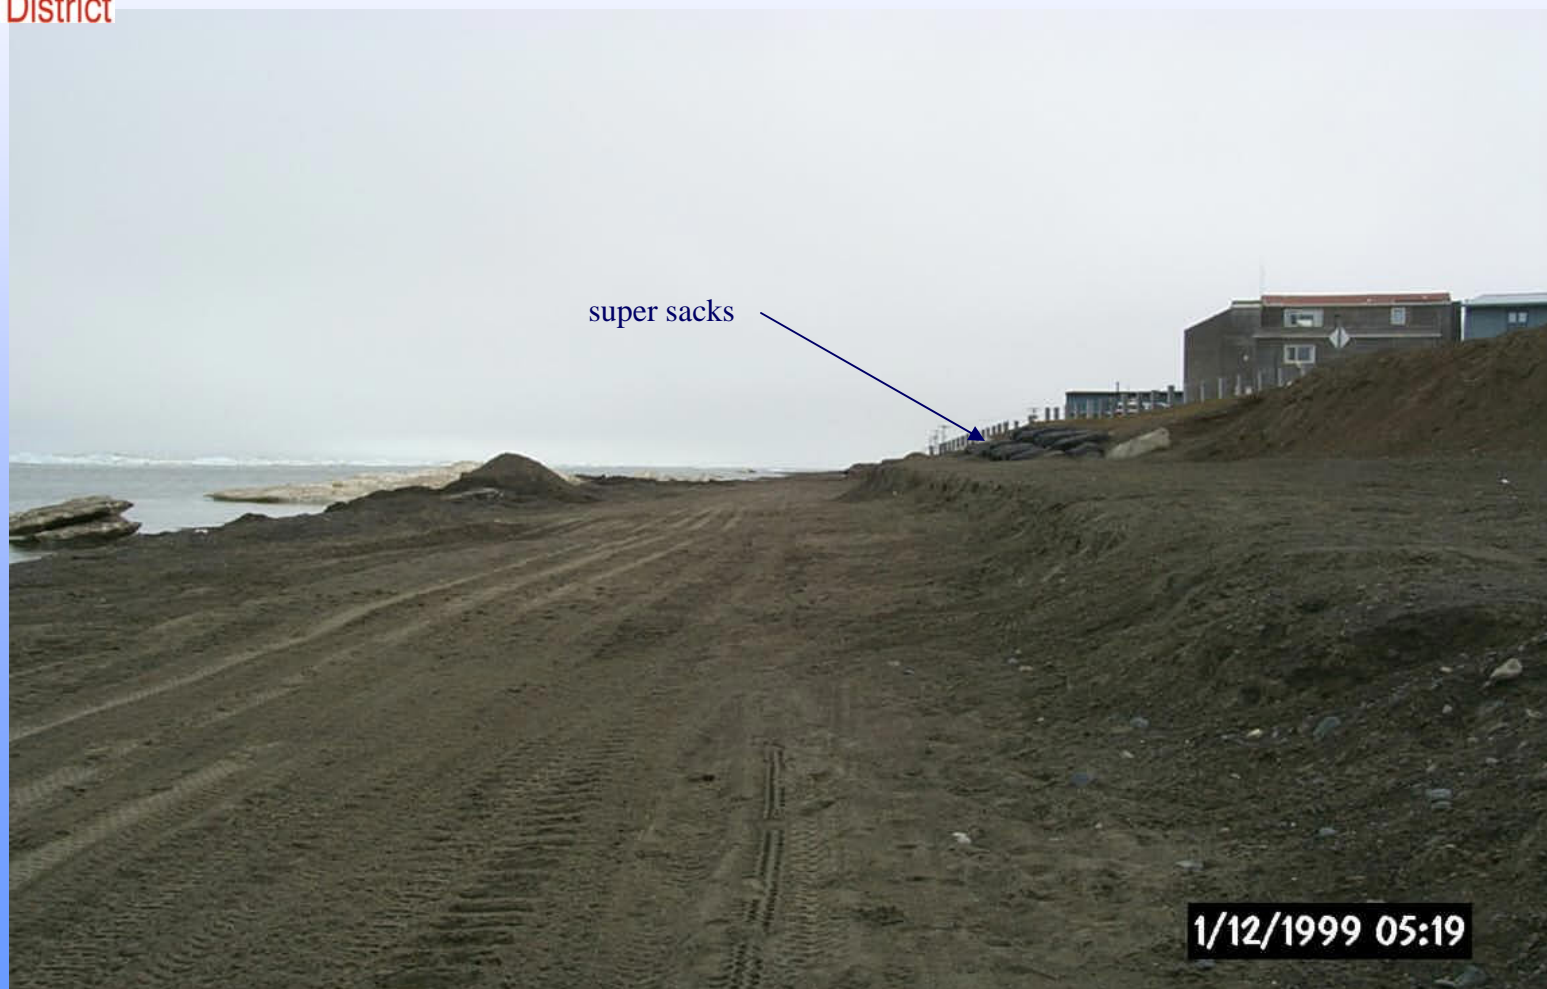
Two erosion control efforts are shown in this photo. Supersack geotextile bags placed in front of the bluff at the most vulnerable part of the city and the remains of beach nourishment with fine material.

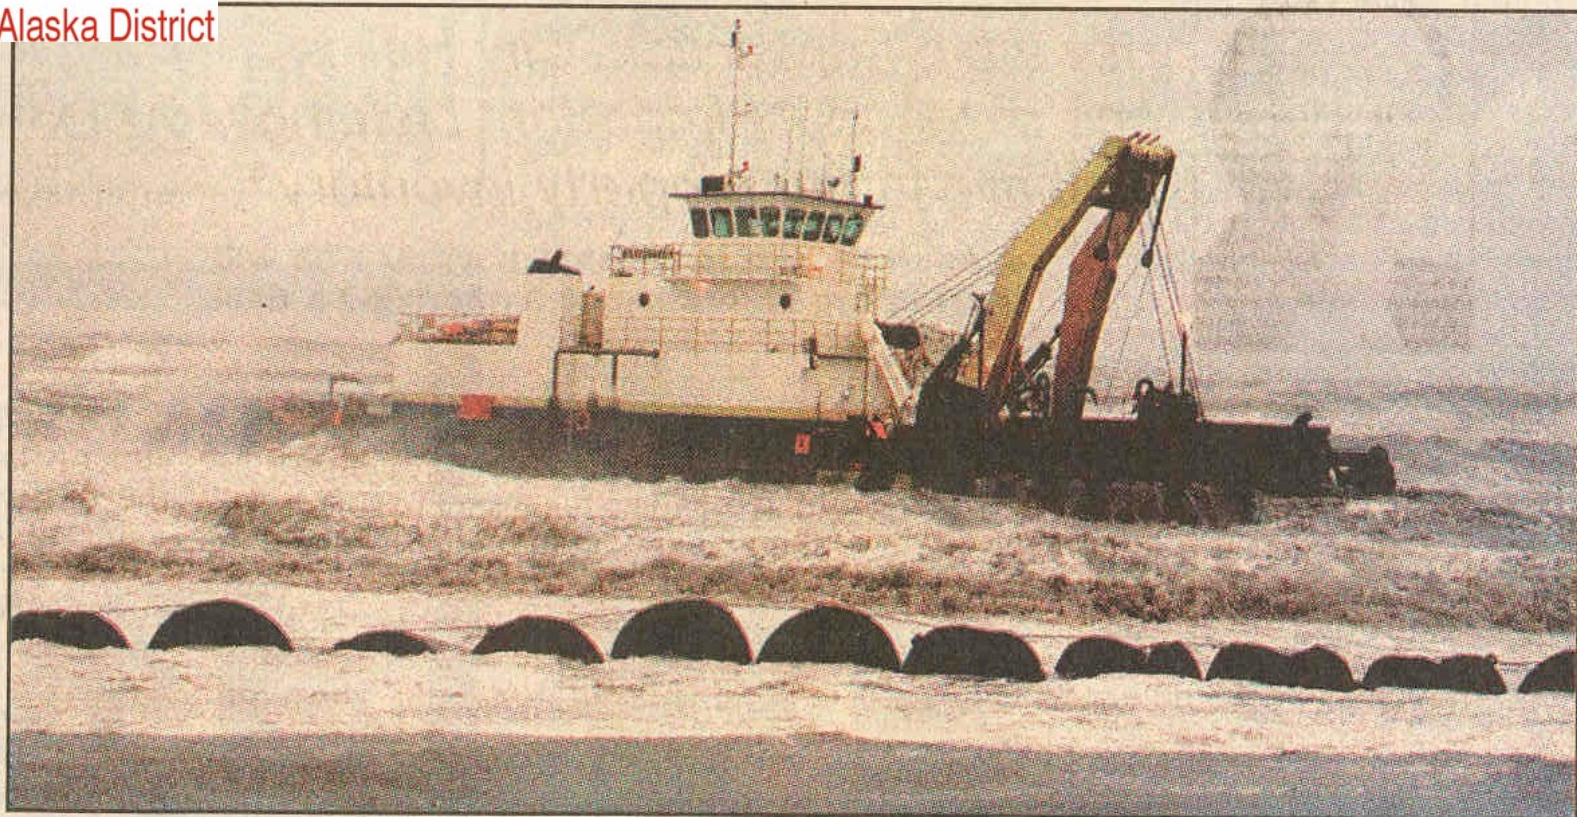
The bought their own dredge in an effort to nourish the beach. The material that they dredged for nourishment was fine material that did not stay in place. This effort stopped when the dredge was grounded during a 2000 storm.

The North Slope Borough's multimillion-dollar off-shore dredge was pounded by waves after it broke loose and grounded itself on the Barrow beach Thursday when a rare summer storm with winds up to 65 mph hit the area.

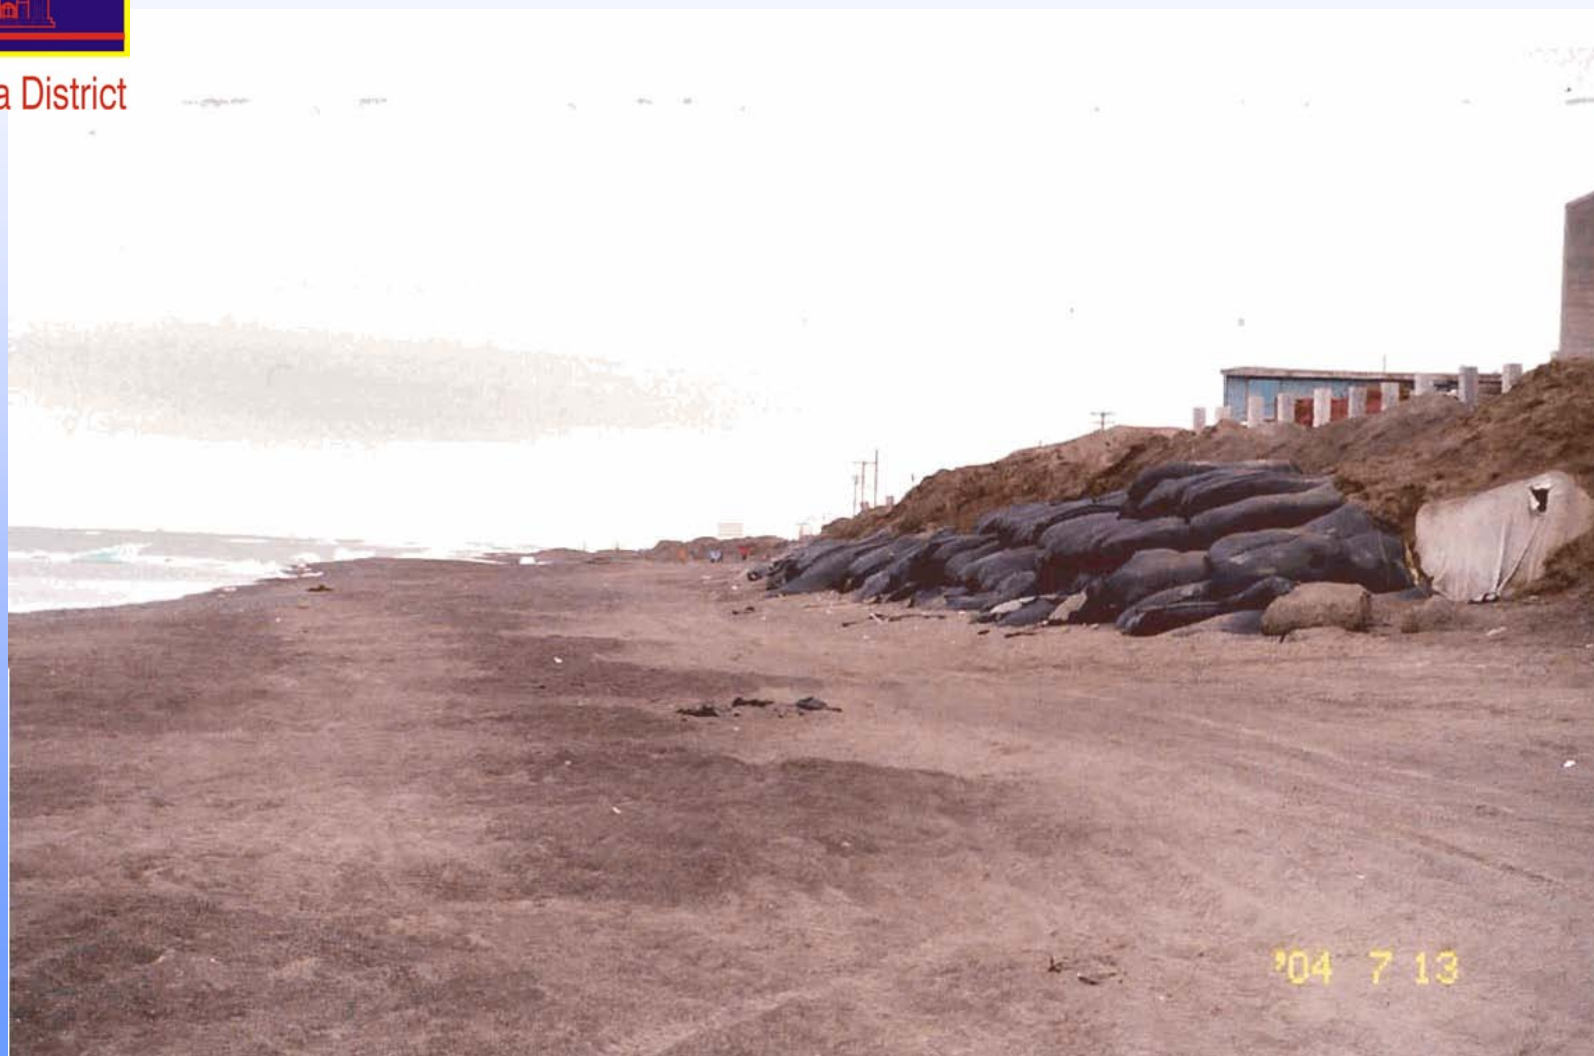
By 2004 the beach nourishment material has been completely washed away and the supersacks are degrading from ice gouging and exposure.

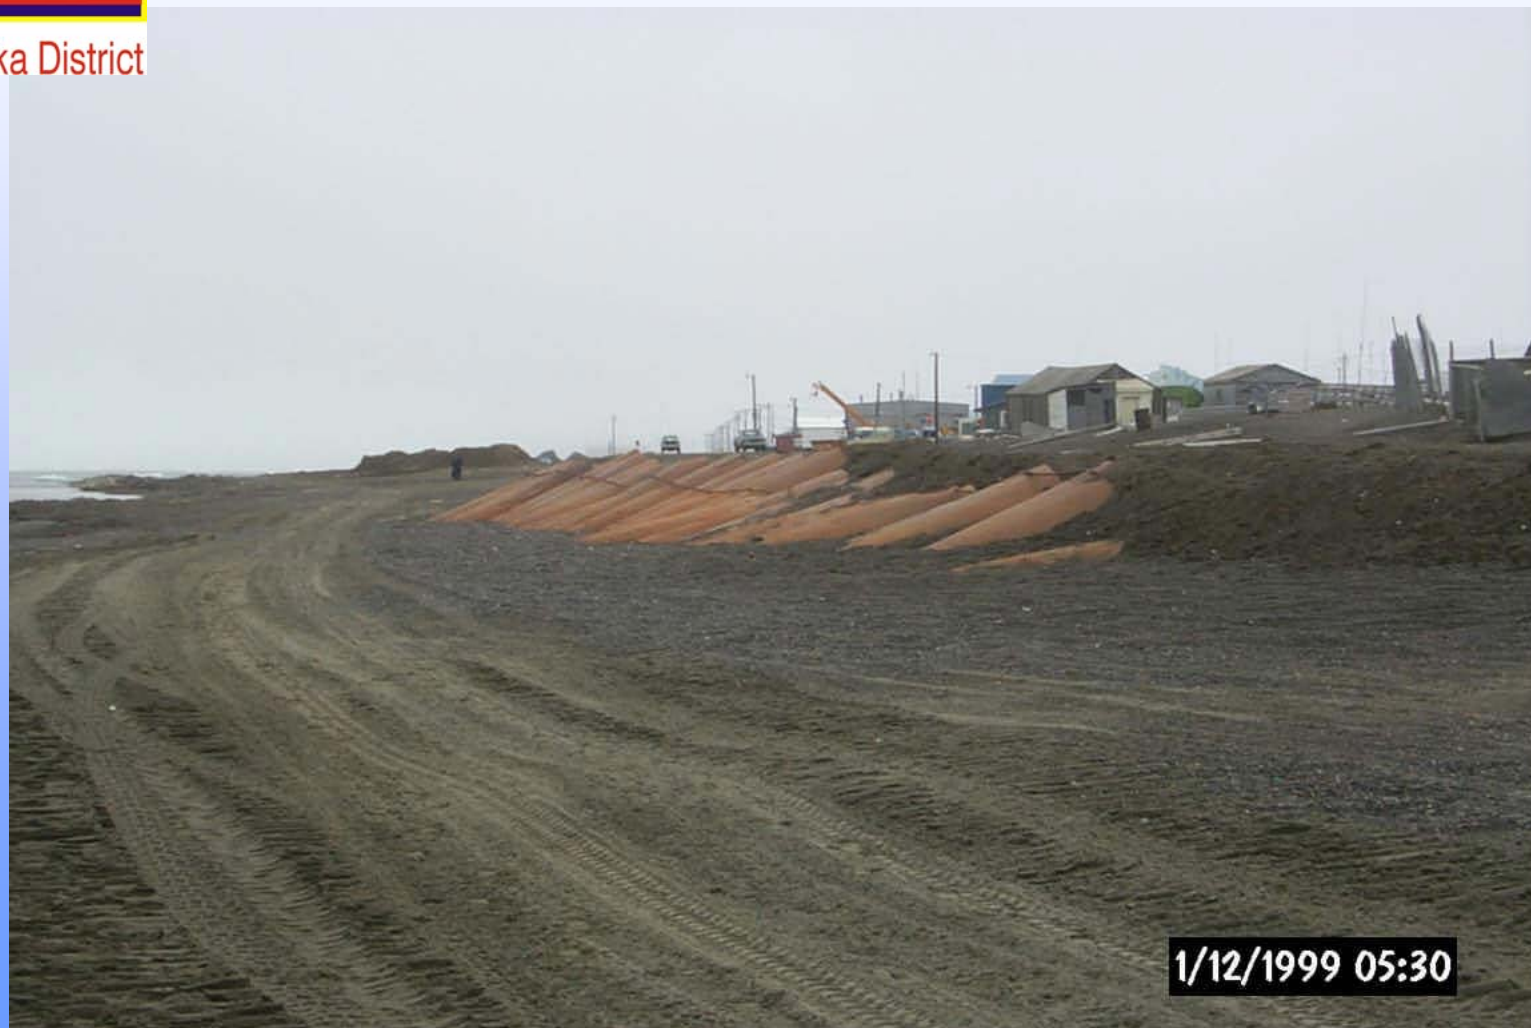
Along a stretch of beach in front of Browerville tar barrels were placed. They have stayed in place and the material surrounding them has varied.

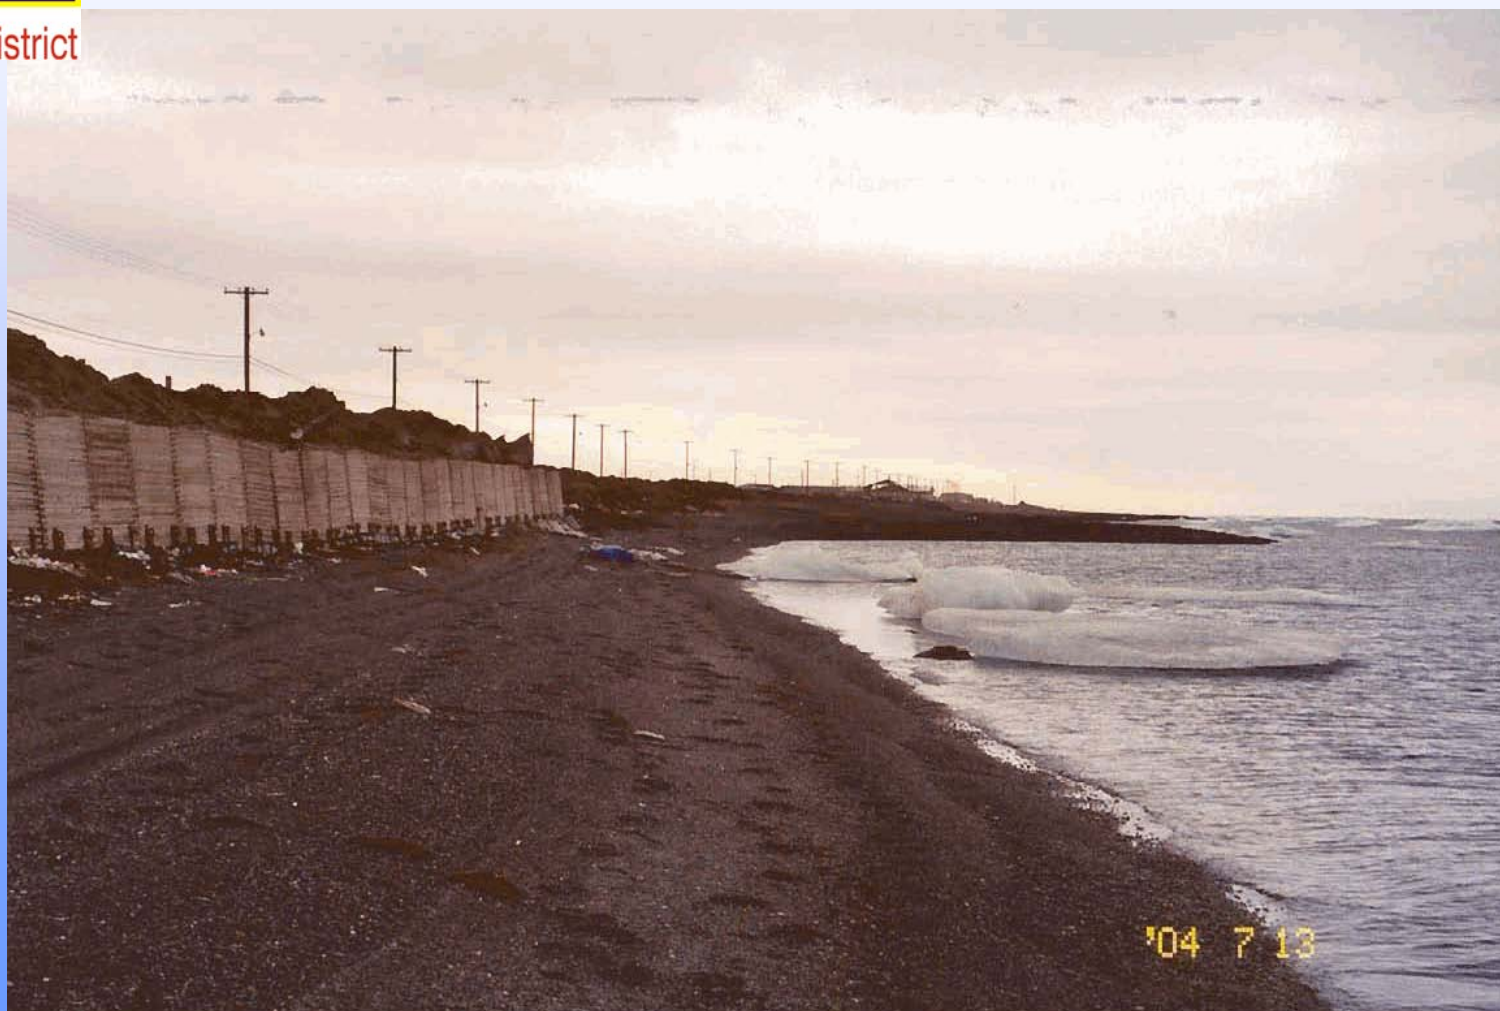
These have since become exposed and the beach narrows considerably in front of the boxes.

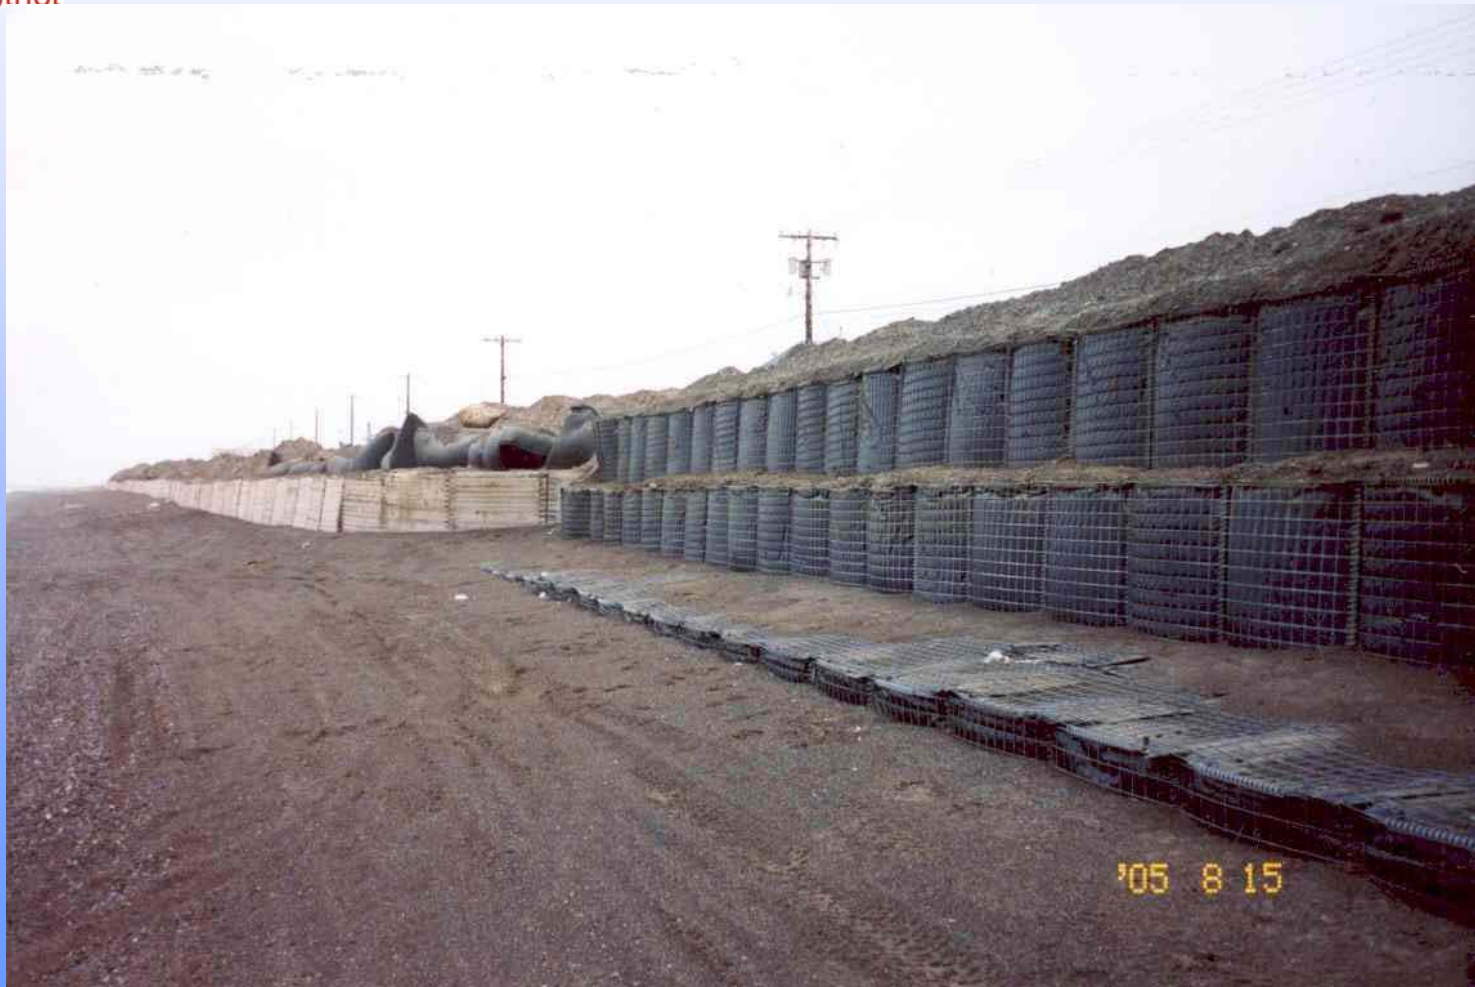
HESCO Concertainer System by upturned utilidor boxes

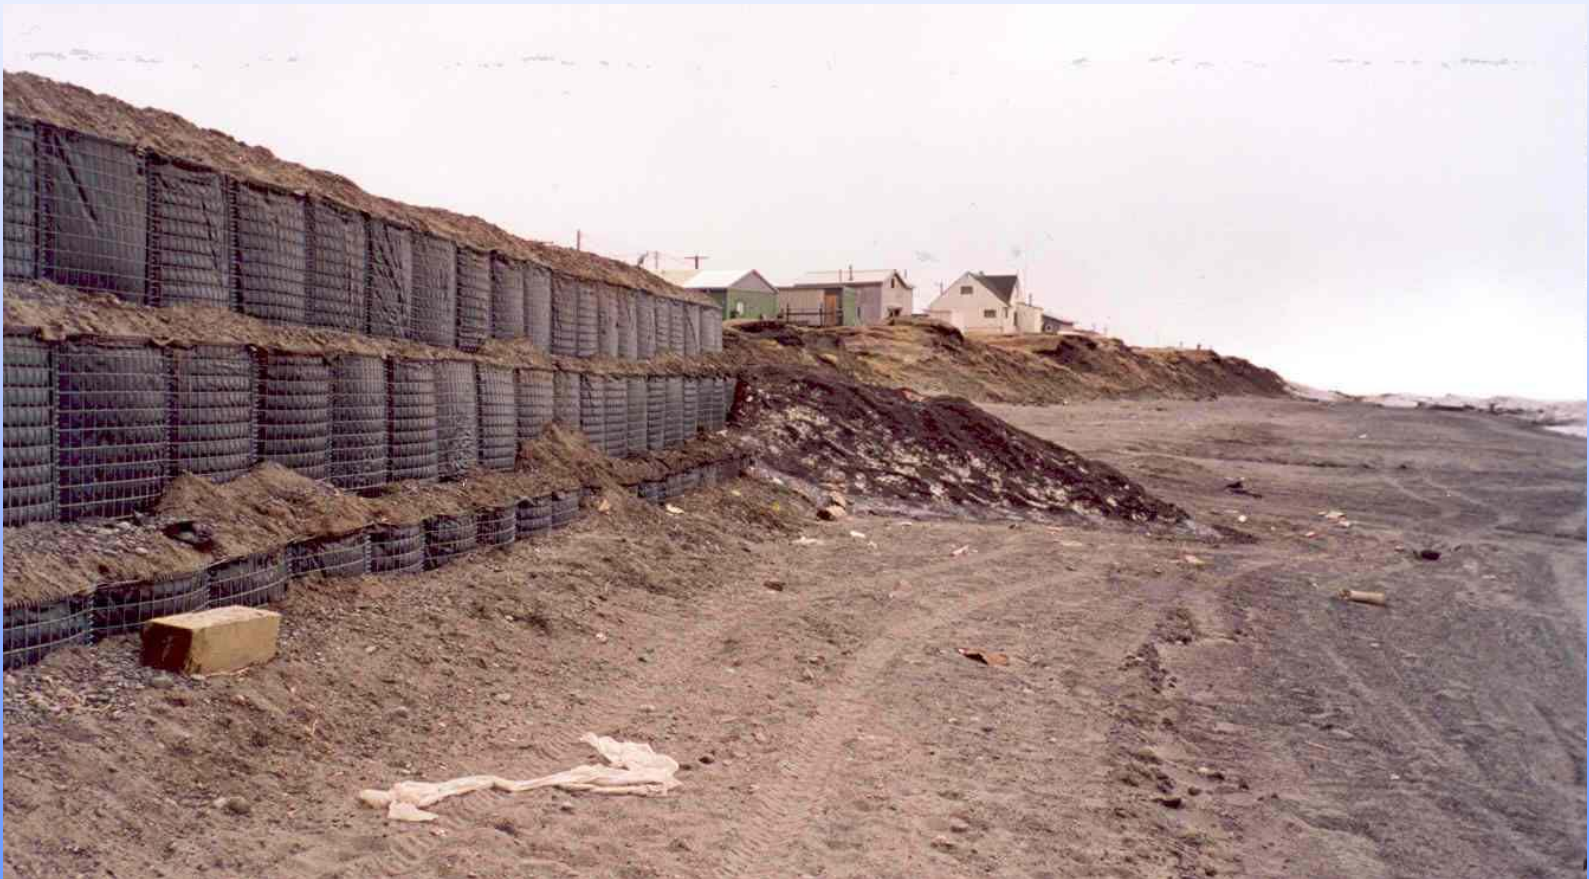
HESCO Concertainer System in front of Barrow

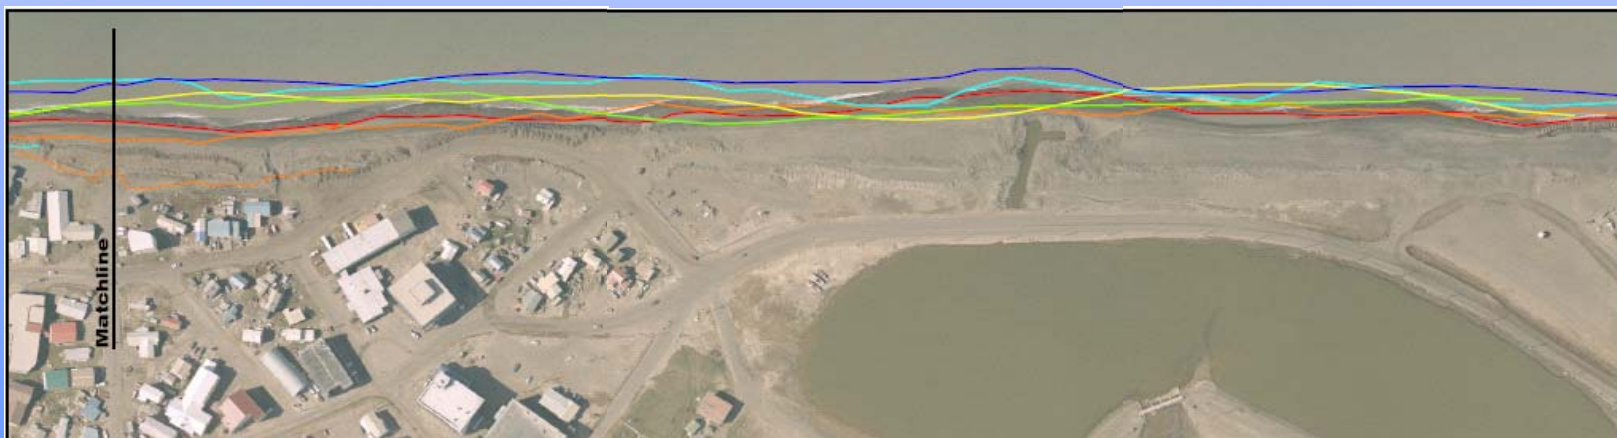
Shore and Bluff Line Change Example of Analysis

Aerial Photography Analysis of the Shore line and Bluff line was performed for the years: 1948, 1955, 1974, 1984, 2003

Interpreted Shoreline: 1948 1955 1974 1984 1997 2003
Top of Bluff: 1948 1955 1974 1984 1997 2003
0 100 200 300 400 Feet 0 50 100 Meters
1 inch equals 200 feet
Image dated August 2003

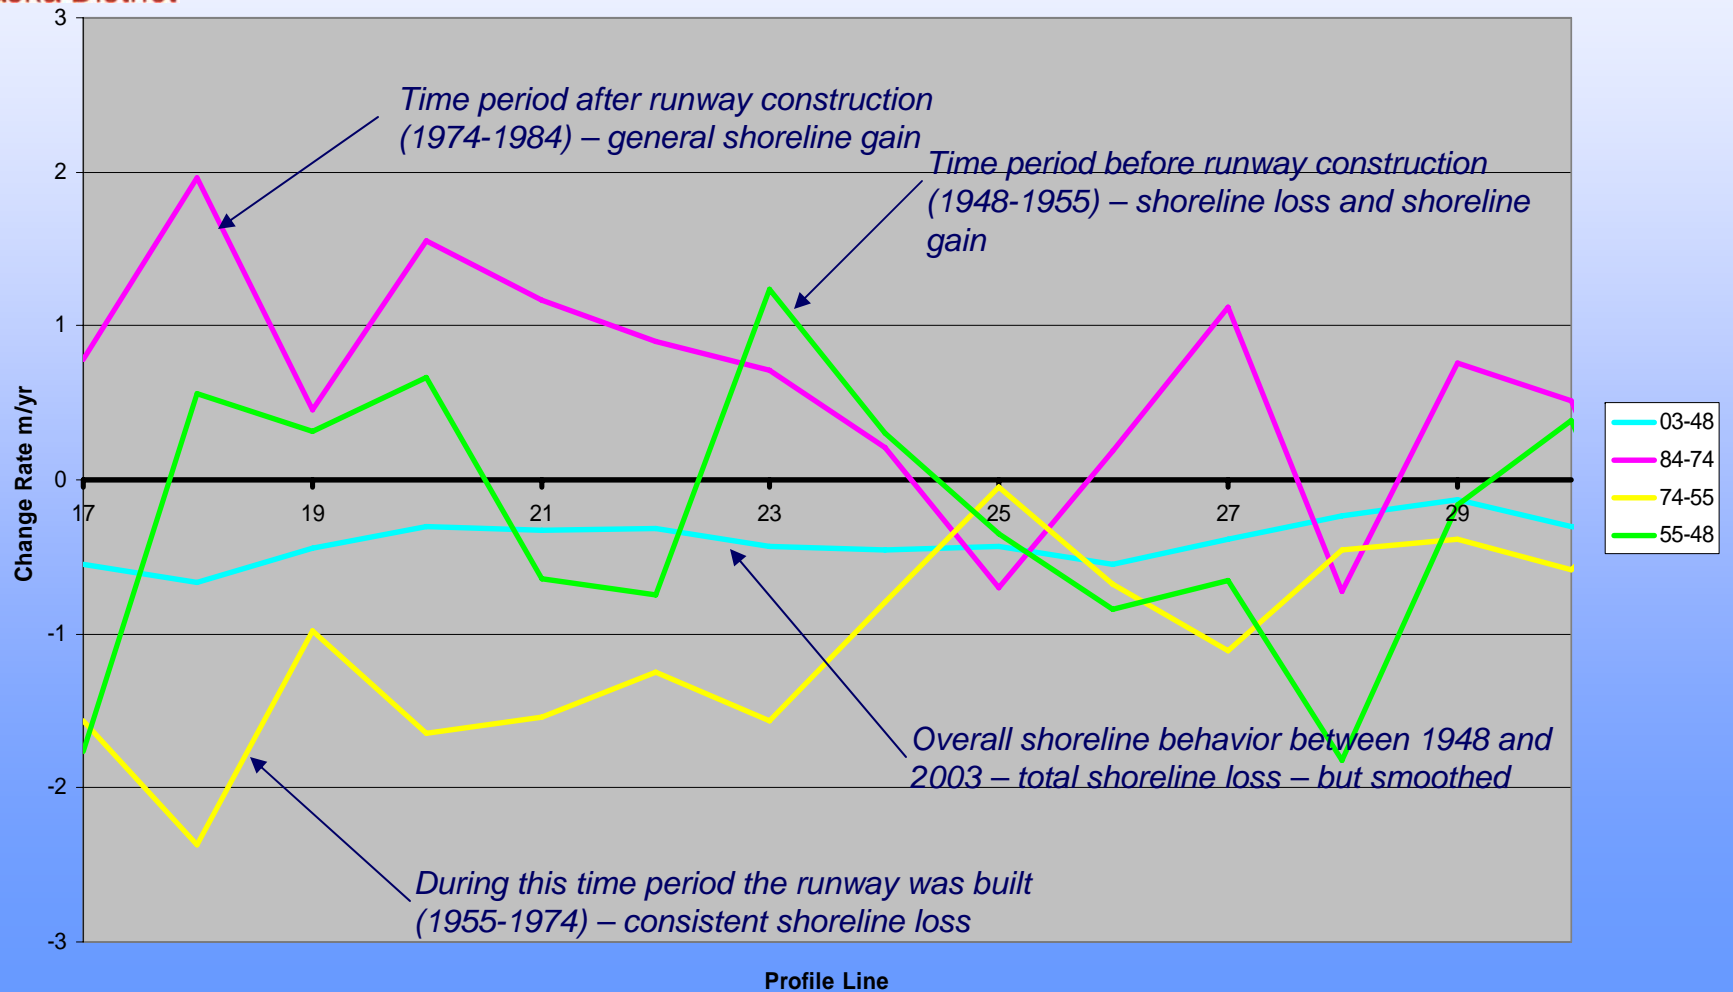
Shoreline Recession Rate Between Stations 17 And 30

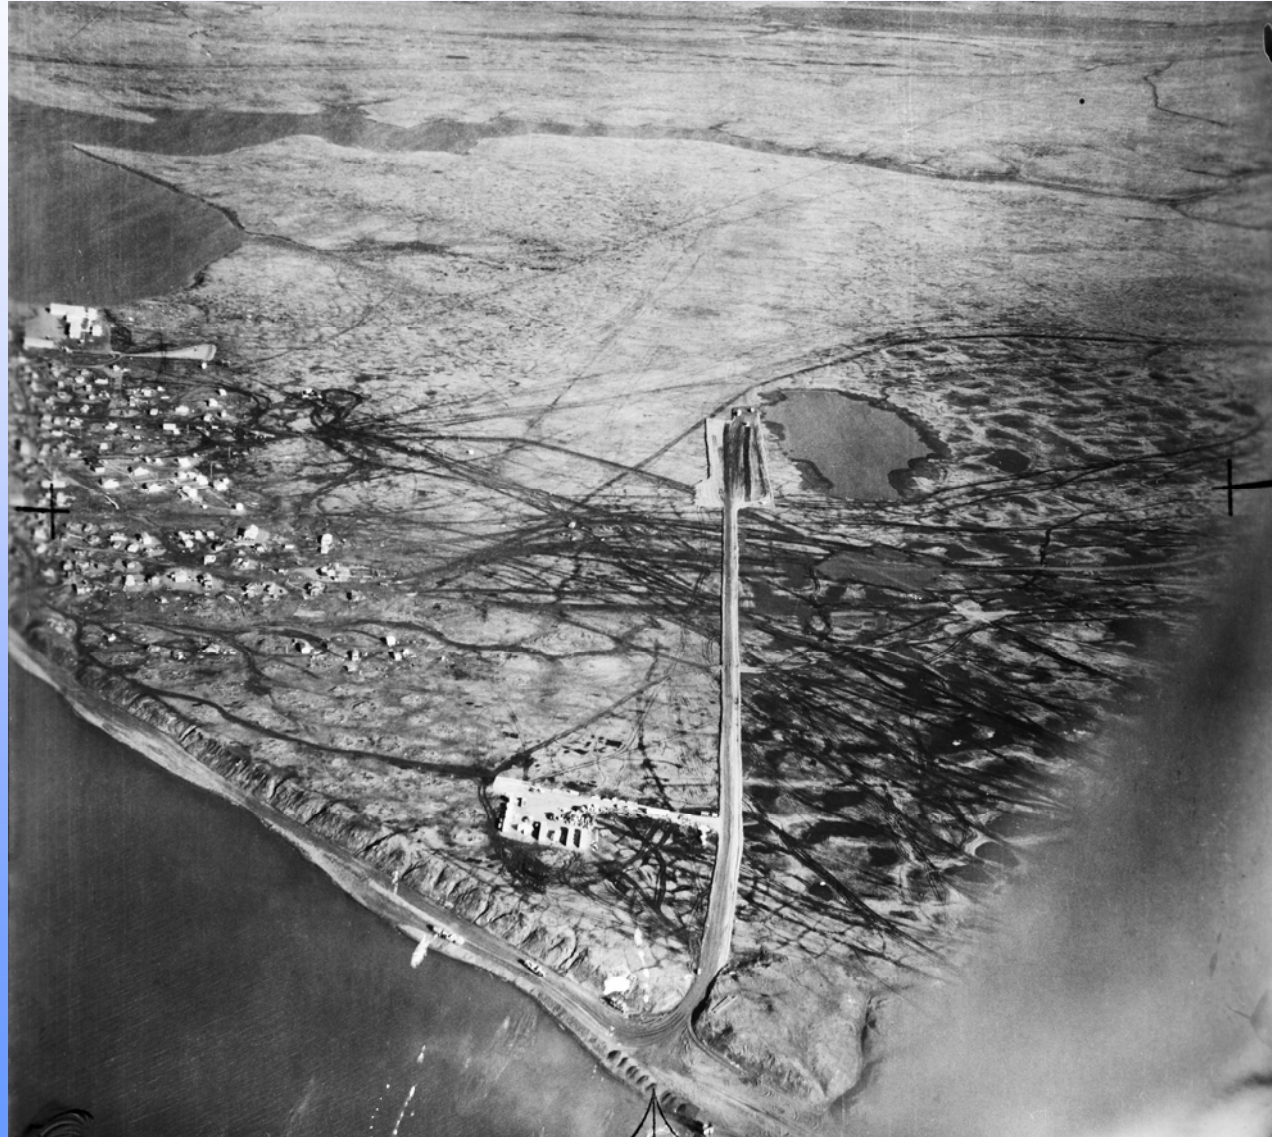
Aerial Photo Indicating Borrow From the Beach for the Airport
